Manhole Inspection Summary

Manhole # S47I__058MH

Insp Date: **4/22/08 10:23 AM**

Location Address: **decker ct**

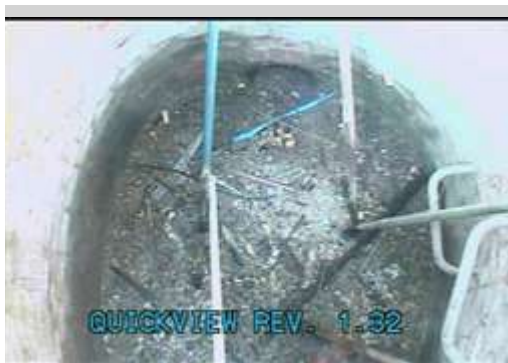
Defect 3

Condition: ☐ Sound ☐ Cracked ☐ Root Intrusion ☐ Deteriorated ☐ Leaks ☒ **Debris**

channel debris

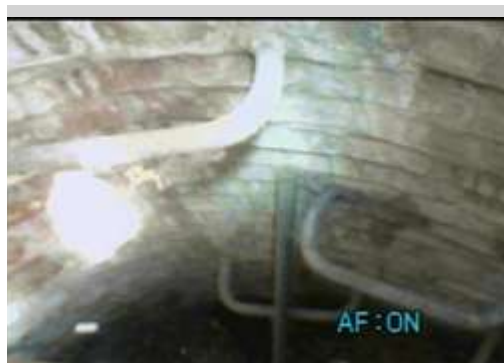
Defect 2

Count: **3** Missing: **0** ☒ **Corroded**

steps

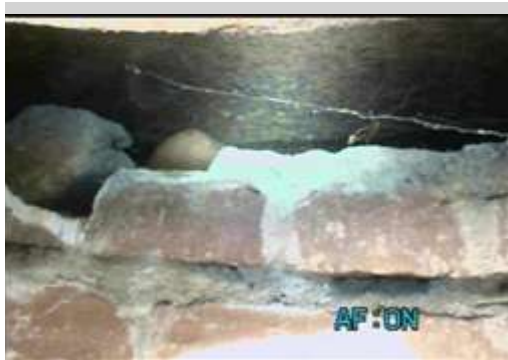
Defect 1

Condition: ☐ Sound ☐ Cracked ☐ Root Intrusion ☒ **Loose Brick** ☐ Deteriorated

Chimney loose bricks, frame adjustment

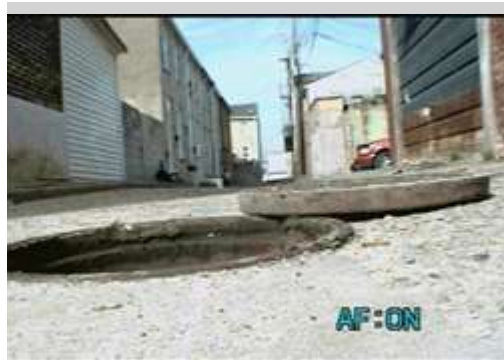
Defect

Diameter: **25.** (in.) Length: **0** (in.) Dist A/B Grade: **1** (in.)
5

cover above grade
